# Manhole Inspection Summary

Manhole # S27A\_\_058MH

Insp Date: **11/30/07 11:51 AM**

**Location** Address: **REAR OF 754 DOLPHIN ST**

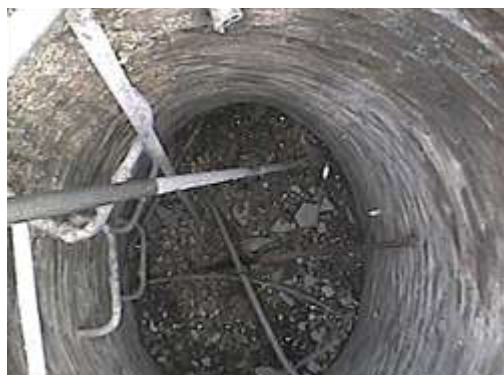
Defect 2

Condition: ☐ Sound ☐ Cracked ☐ Root Intrusion ☐ Deteriorated ☐ Leaks ☒ **Debris**

CHANNEL DEBRIS

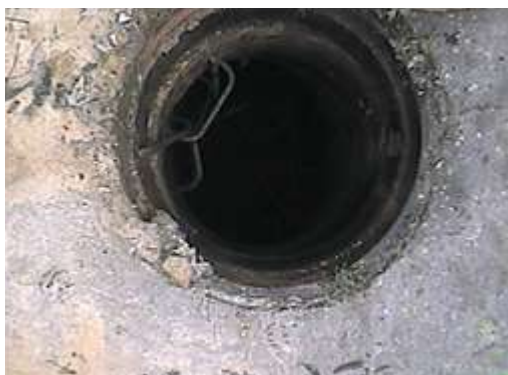
Defect 1

**Frame** Offset: **1** (in.) Condition: ☒ Sound ☐ Cracked ☐ Leaks

FRAME OFFSET

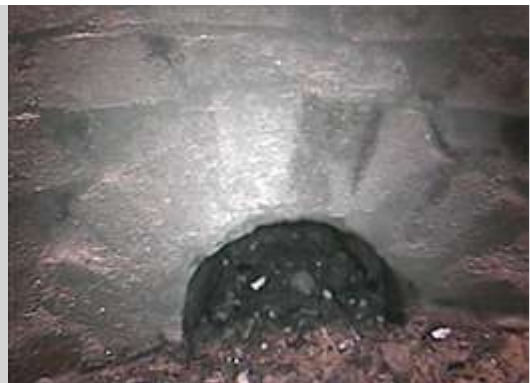
12 O'Clock Outflow

MEDIUM SILT IN PIPE.

Deposits: ☐ None ☐ Mud ☐ Sludge ☒ **Debris** ☐ Grease

Silt Depth: **2** (in.) Deposits Extent: **Medium**
